# Shattuc Tower

1924, B&O Built, Shattuc Illinois

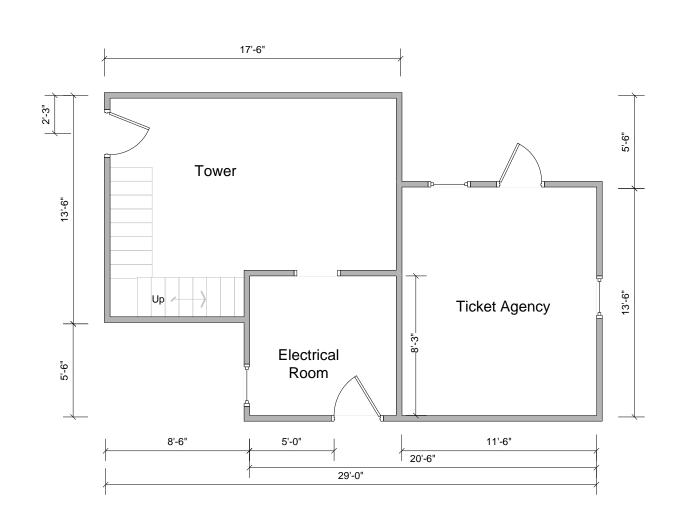
Cabinet: E-1

Item: Electrical First Floor

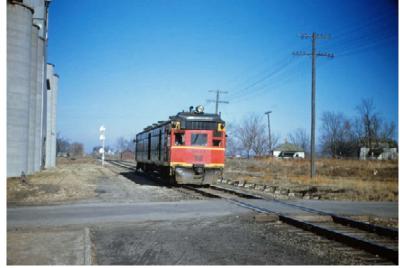
In this view looking North from Shattuc tower you can see signals 1 and 2. These signals were mechanical signals at one time but were replaced before 1954. The pipeline that can be seen to the right of the tracks controlled the signal. In this view the pipeline is abandoned.

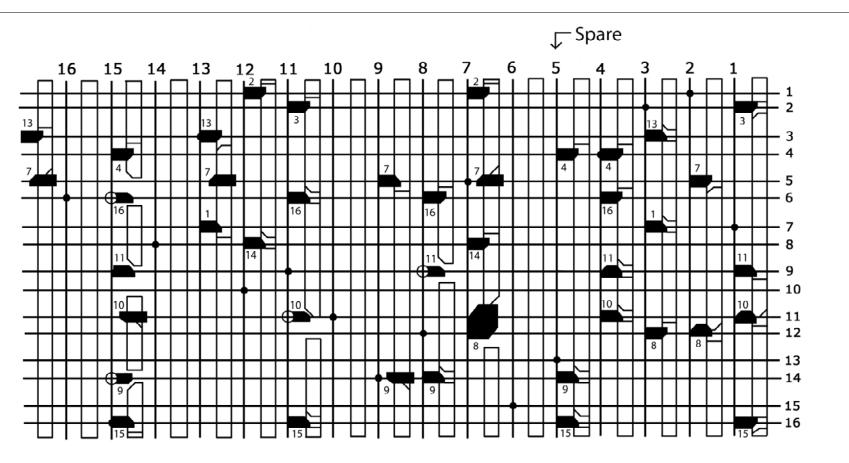
## Shattuc Dog Chart Improved S&F Mechanical Interlocking Machine

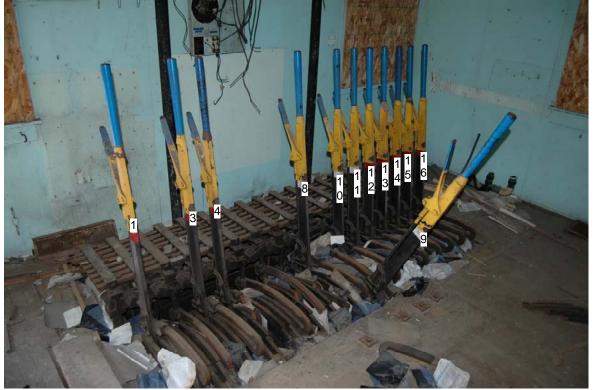
Cabinet: L-2

Shattuc Lever Bed Current 9-7-2009

Item: Photo of Shattuc Lever Bed

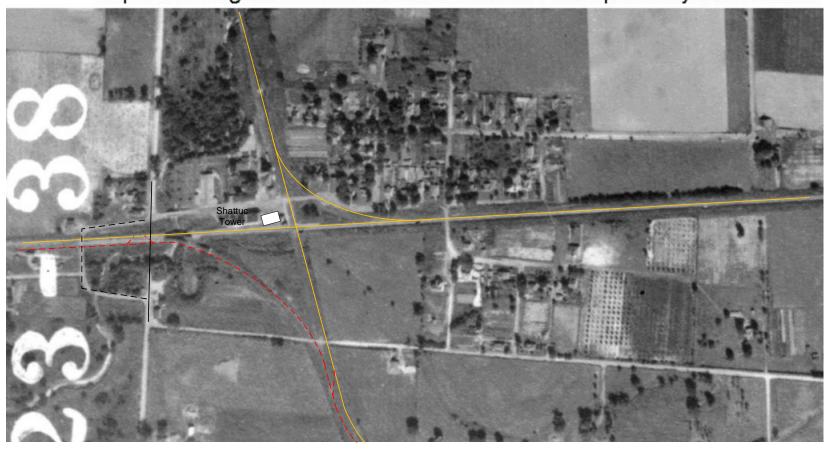
Cabinet: M-1

# Aerial View of Shattuc, IL, 1938 http://www.isgs.uiuc.edu/nsdihome/webdocs/ilhap/county/clinton.html

Item: Aerial photo with track layouts.

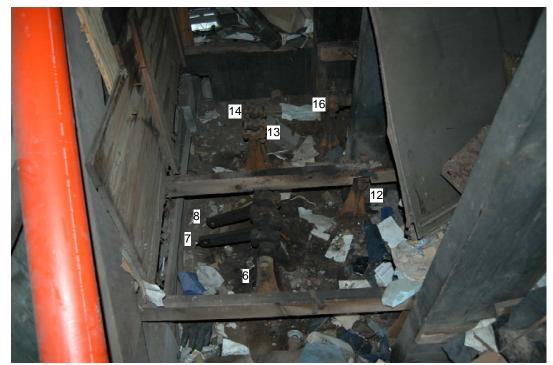
Cabinet: P-2

Remains of Vertical Cranks and Rocker Shafts below the floor of Shattuc Tower

Lever 16 Rocker Shaft

Vertical Cranks 6/7/8

Item: Current Shattuc Tower Crank/Rocker Shaft Remains.
